TITLE	:	Report on the small-scale fire properties of Elastopor H" polyurethane spray foam material as determined by the SANS 10177 Part10 test protocol
REQUESTED BY	:	Elastogran South Africa (Pty) Ltd P O Box 524 EDENVALE 1610
CONTRACT No	:	FTC09-095
AUTHOR(S)	:	K. van Dyk
DATE :		21 September 2009

The purpose of this investigation was to assess the small-scale fire properties of "Elastopor H" polyurethane spray foam material. The medium-scale horizontal flame spread properties were determined in the inverted channel facility in accordance with the SANS 10177 Part 10 test protocol.

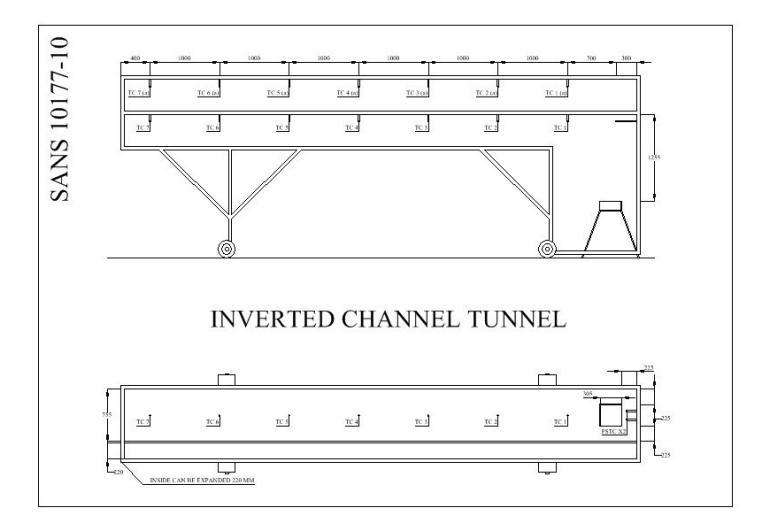
The delivered test specimen consisted of the foam sprayed to a thickness of between 20 and 30 mm onto a non-combustible fibre-cement board backing material. The delivered panels were installed in the inverted channel tunnel facility (Figure 3.1.1).

Figure 3.1.1: Diagram of SANS 10177 Part 10 inverted channel testing facility

Temperatures were measured during the investigation with thermocouples located below the installation at 1 m centres. The test installation was exposed to the thermal output of three litres of n-hexane, which was placed in the fire source tray. Temperatures were continuously recorded and observations were noted of the behaviour of the material.

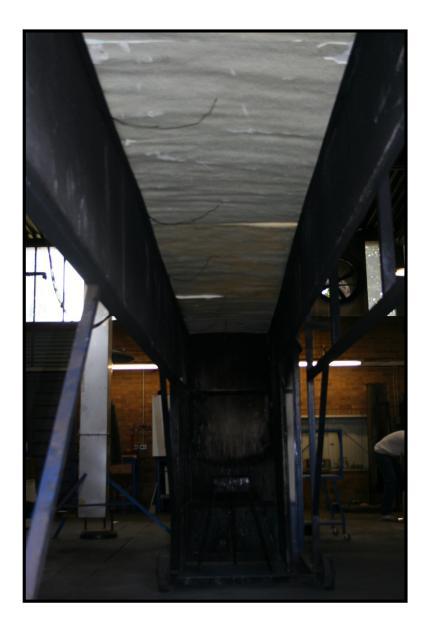
The installation prior to the ignition of the fire source is shown in Figure 3.1.2.

Figure 3.1.2: Test installation prior to ignition of fire source

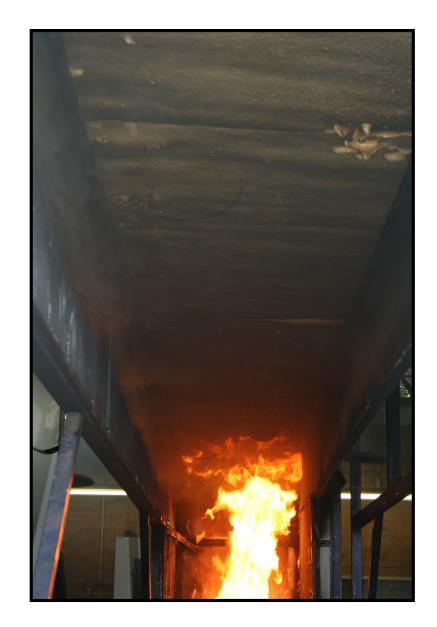
The material above the fire source discoloured and delaminated after approximately 90 seconds. The material above the fire source ignited sporadically from 7 minutes and 45 seconds (Figure 4.1.1) but no sustained burning of more than 10 seconds was noted. This pattern continued up to 12 minutes after commencement of the test when the sporadic ignition also seized.

Figure 4.1.1: Sporadic ignition of material above fire source (t = 7 ³/₄minutes)

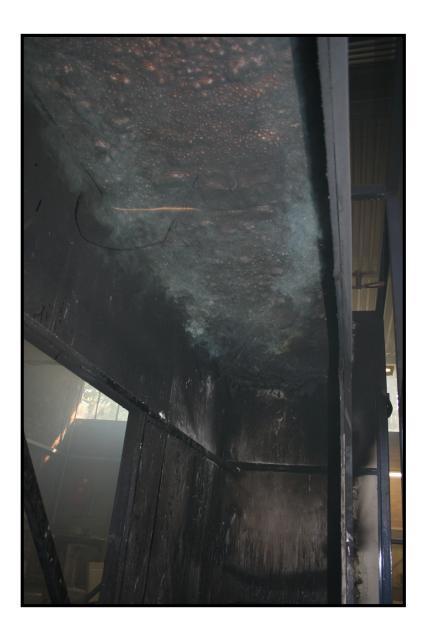
Figure 4.1.2 shows the installation subsequent to completion of the test. No fire propagation beyond the area under direct influence of the fire source was observed.

Figure 4.1.2: Test installation subsequent to completion of test

The material as tested did not display a propensity to propagate fire from a single point of origin. The material would therefore be suitable for use within agricultural applications from a fire safety point of view. The material would also be suitable for external application during roof refurbishment as well as under-tile application in domestic dwellings.

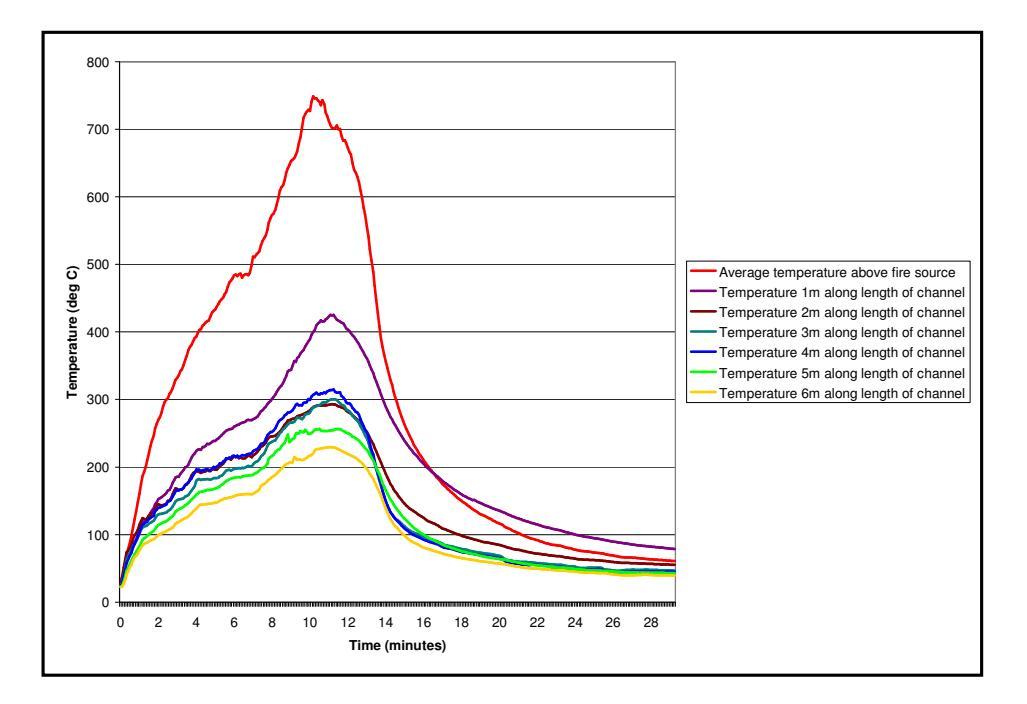
The temperatures recorded in the furnace are depicted graphically in Figure 4.1.3.

Figure 4.1.3: Temperatures recorded during SANS 10177-10 test on Elastopor H
